ABOVE GROUND SURVEYS

Roof Condition Report

Survey Date:	5th November 2025
Report Date:	06 December 2025
Location:	51.3455°N, 0.5425°E (Swanley, Kent)
Survey Method:	UAV Aerial Inspection
Equipment:	DJI Mavic 3 Pro (Hasselblad Camera)
Images Captured:	4 High-Resolution Photos (36.5MP each)
Analysis Method:	Automated Computer Vision Processing

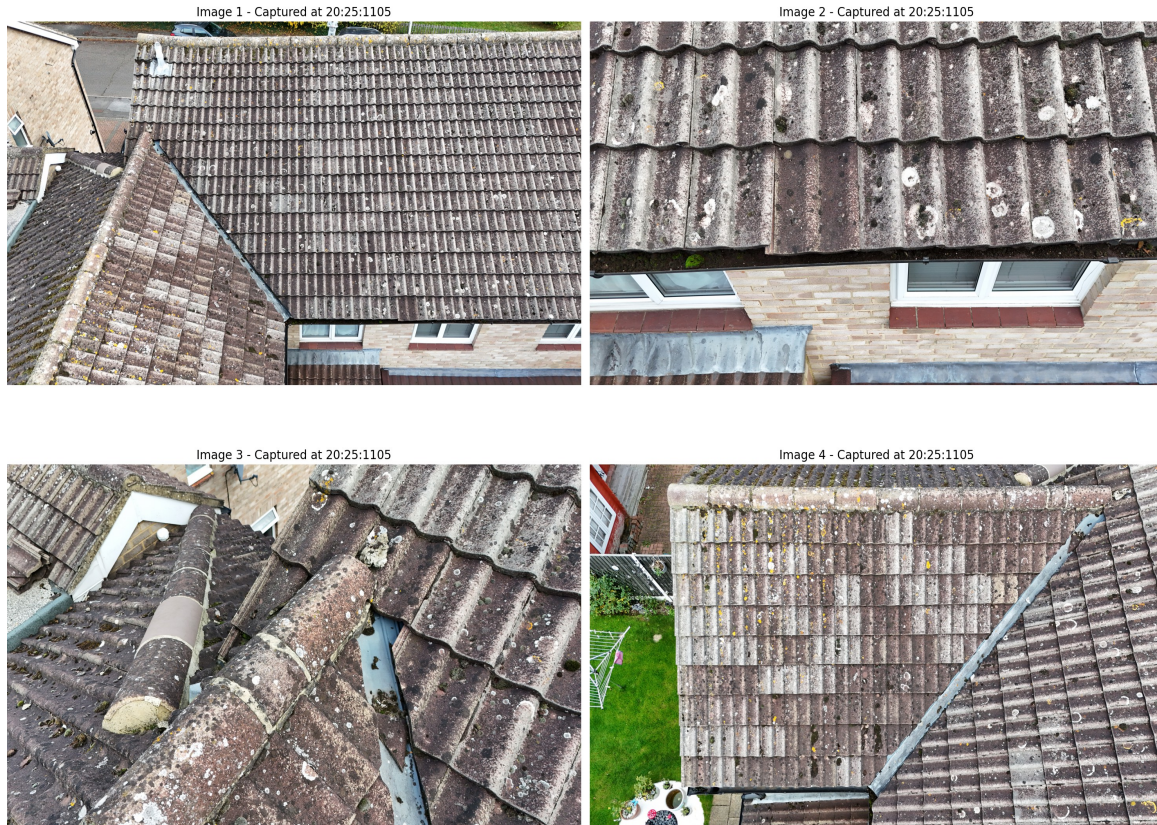
Figure 1: Overview of captured aerial imagery showing all four survey positions

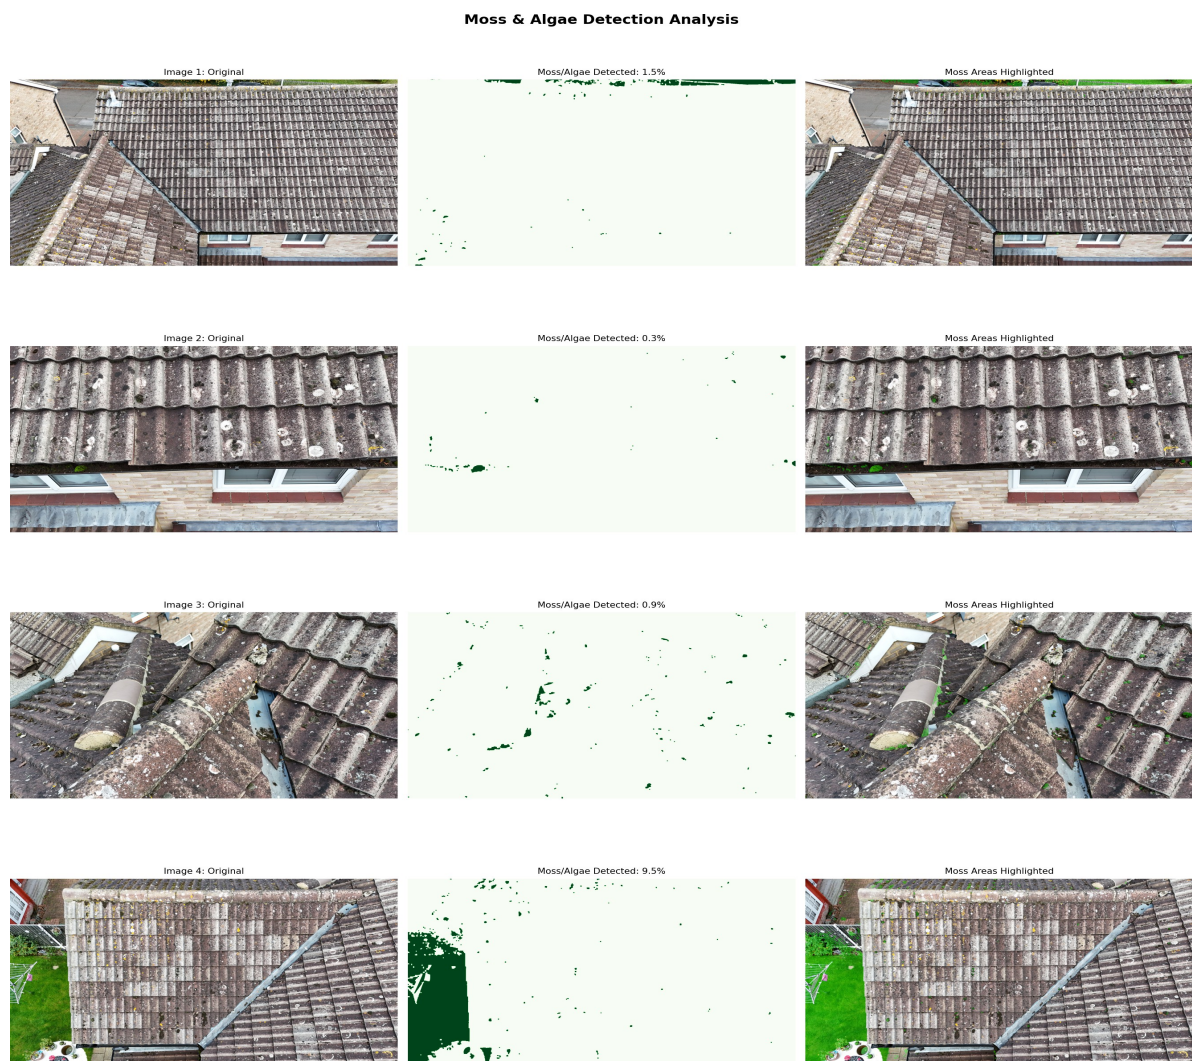
The following analysis identifies areas of biological growth (moss, algae, lichen) on the roof surface. Green highlighted areas indicate detected growth. Biological growth can retain moisture and potentially cause tile degradation over time.

Figure 2: Moss and algae detection analysis - green areas indicate biological growth

- Monitor moss/algae growth - treatment may be needed if coverage exceeds 10%
- Consider protective coating if weathering progresses
- Schedule follow-up aerial survey in 2-3 years

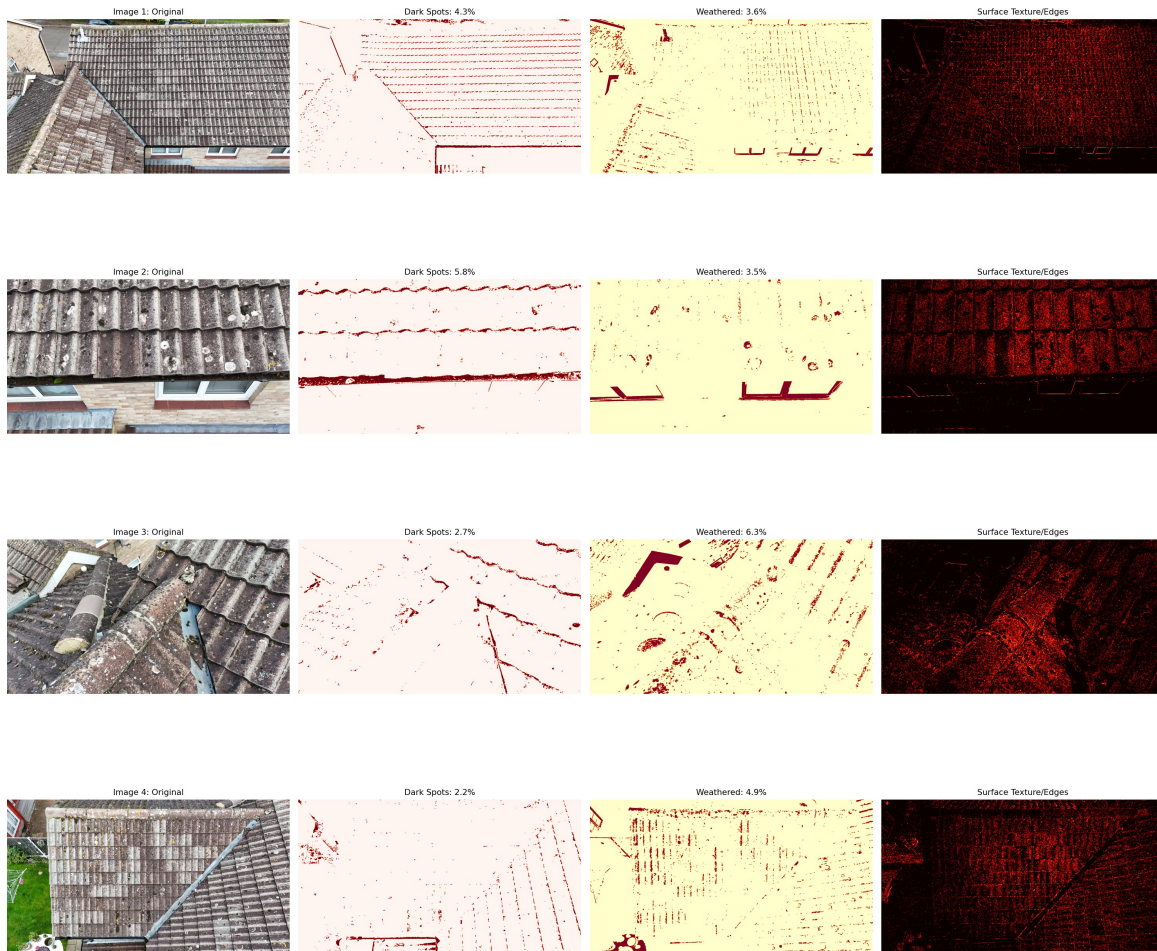
Figure 3: Surface condition analysis showing dark spots, weathering, and texture maps

Image	Dark Spots (%)	Weathered Areas (%)	Texture Variance	Color Uniformity
Image 1	4.32	3.60	3,939	4,841
Image 2	5.76	3.54	3,451	4,532
Image 3	2.66	6.27	2,694	4,049
Image 4	2.23	4.87	3,417	4,090
Average	3.74	4.57	3,375	4,378

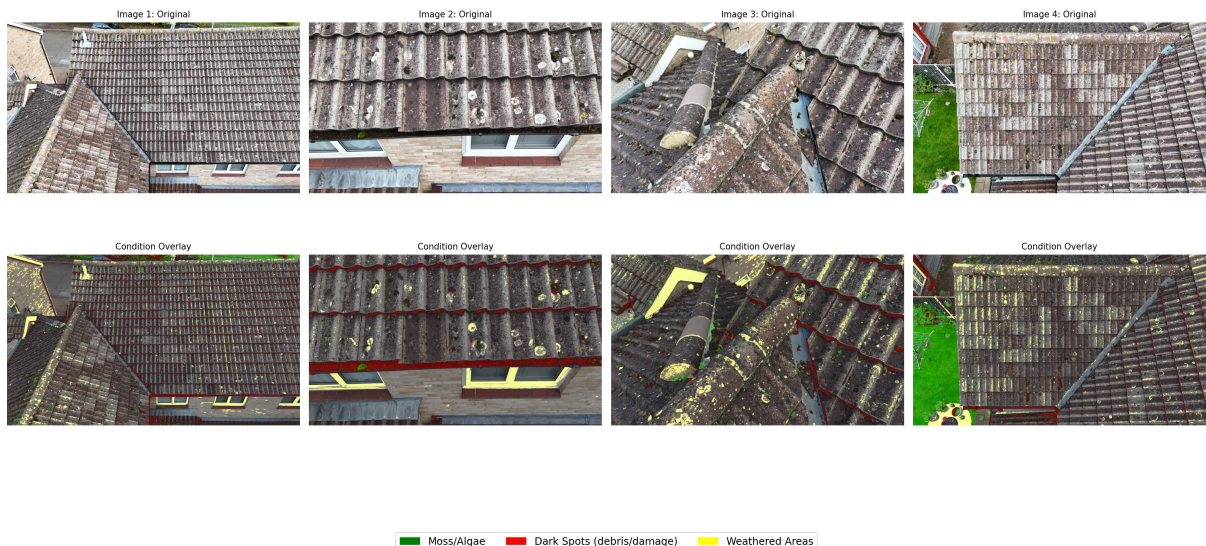
Figure 4: Combined condition overlay showing all detected issues

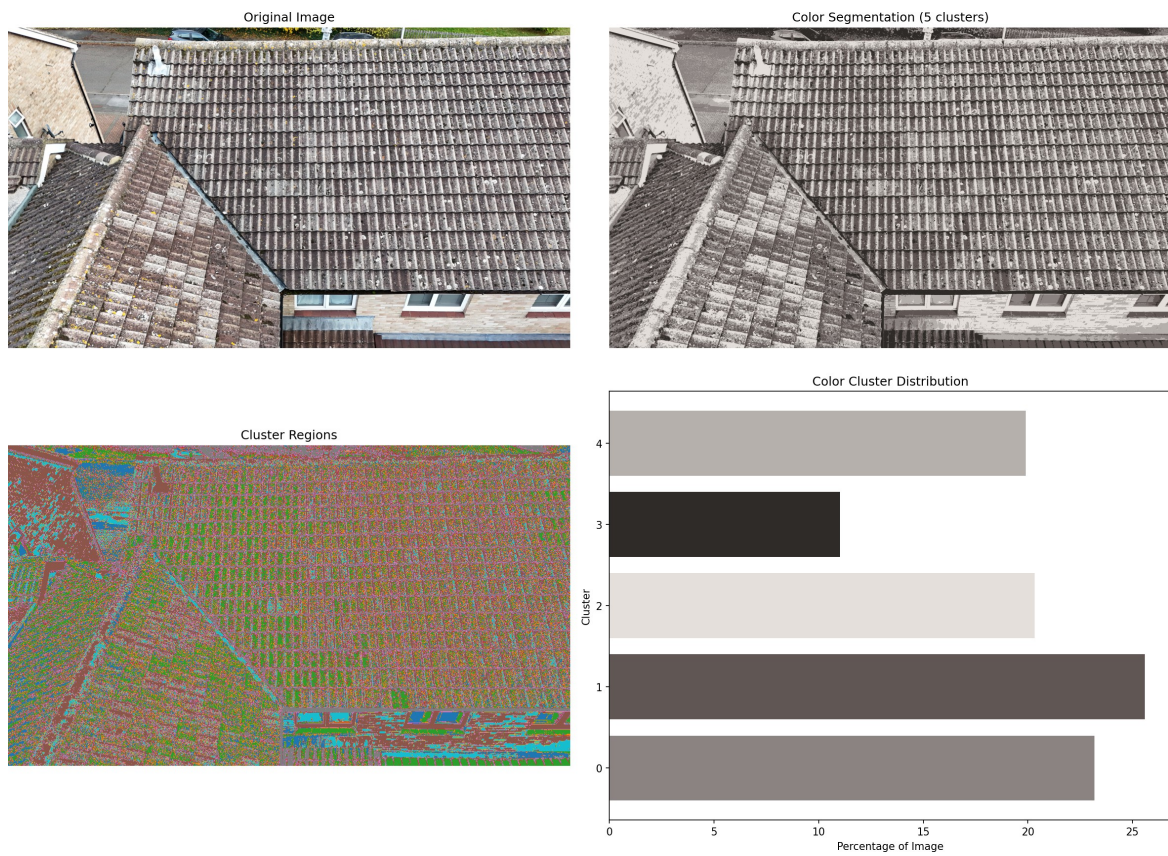
Figure 5: Color segmentation showing distinct surface regions
